# ATA Associates, Inc.

Re: 2014 Sea Doo GTX 155S

## SUMMARY INSPECTION REPORT

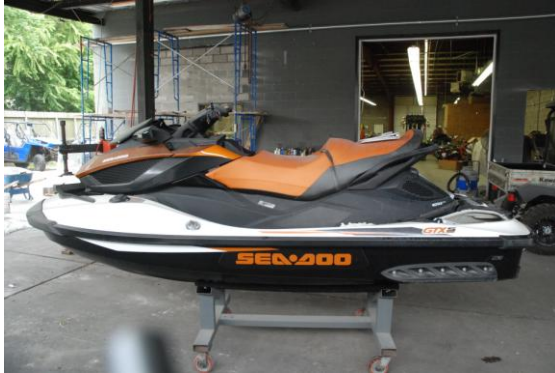
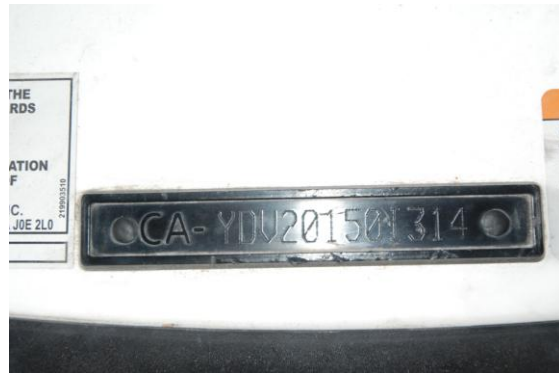
The Vessel, a 2014 Sea Doo GTX 155S, was inspected on 8/19/2014 at Wild West Honda in Katy, Texas. The unit was stored outside. Information from the Owner indicated that he drained the hull of water and transported the vessel to Wild West Honda the day after the incident. The service manager informed me that the only service performed on the vessel was to remove the hatches and drain any remaining water from the hull. No other maintenance was reportedly performed on the vessel.

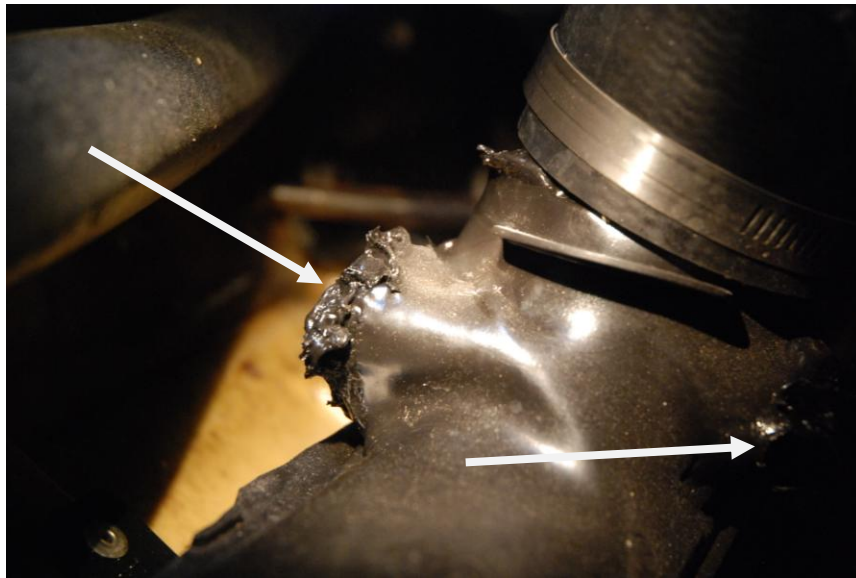
The inspection revealed that the plastic resonator, a component of the exhaust system, had two melted holes in it.

Information gathered from the inspection and the Sea Doo maintenance manual indicates that the plastic resonator failed due to the absence of cooling water flowing through the exhaust.

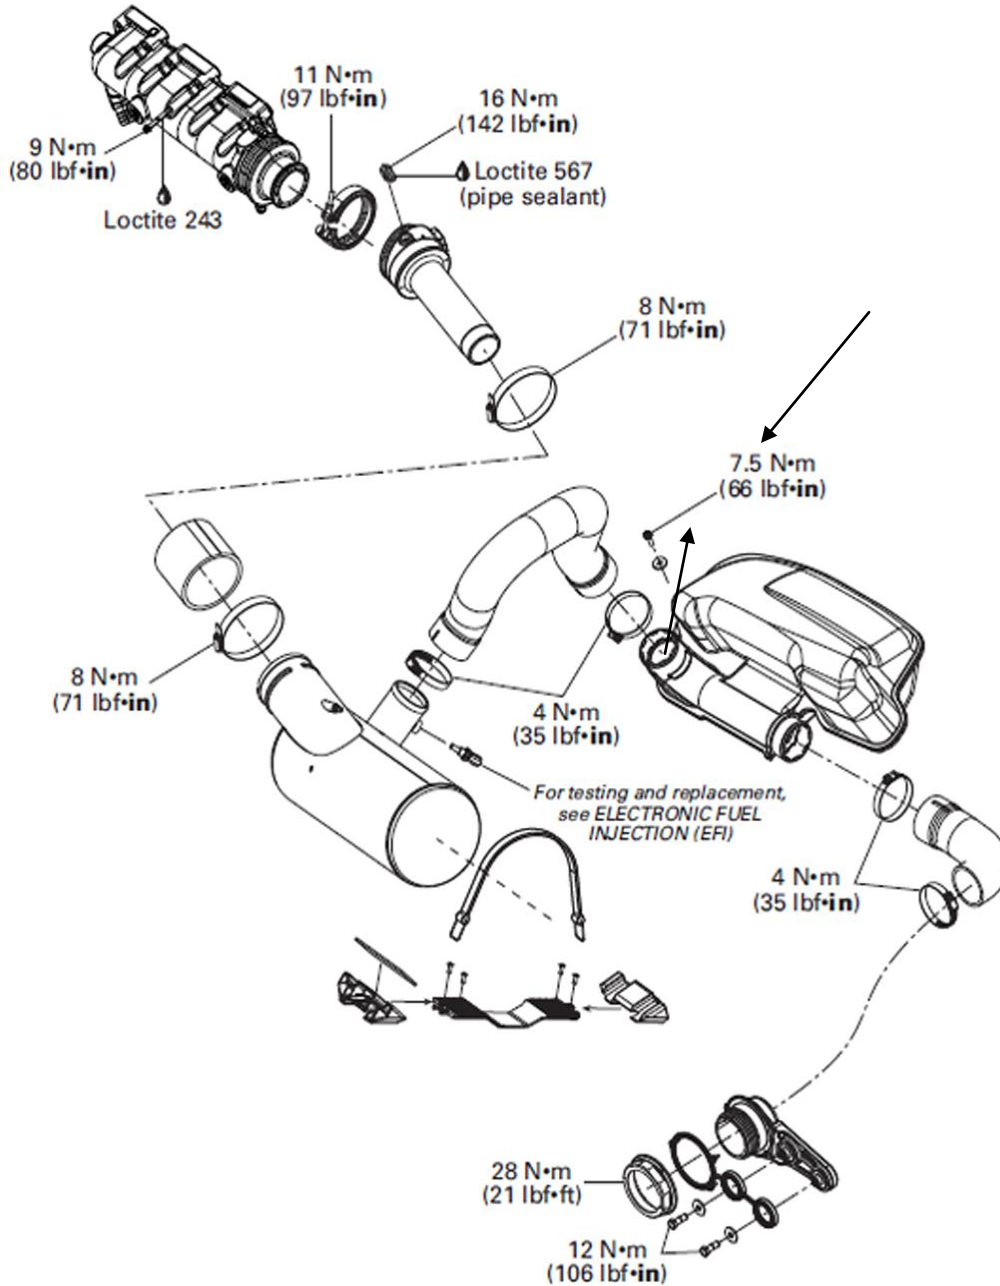
The exhaust system, shown below, requires an outside water source to flow through it and keep it cool.

- A) Analysis of the exhaust and cooling system indicates that if for any reason the impeller should become inoperable or the cooling water pressure port becomes plugged the engine will not receive any cooling water and the non-metallic components in the exhaust system will fail.

- B) There are no check valves or flappers in line with the exhaust to prevent water from entering the hull if any part of the exhaust system is breached.

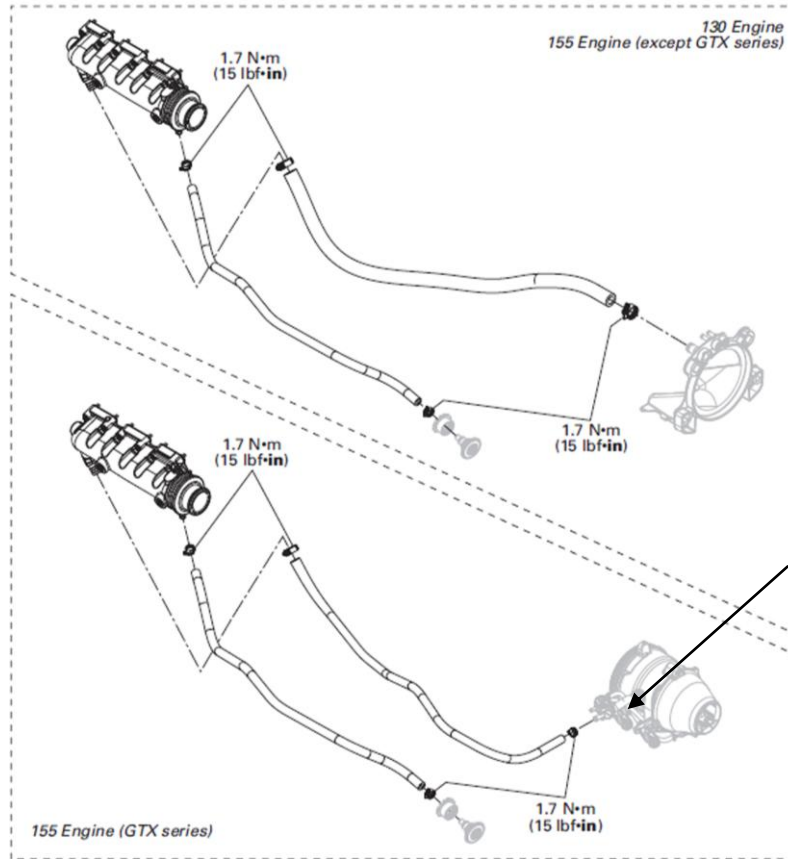
On the model 155S, this cooling water is obtained through the use of a pressure port taken off of the main propulsion system.

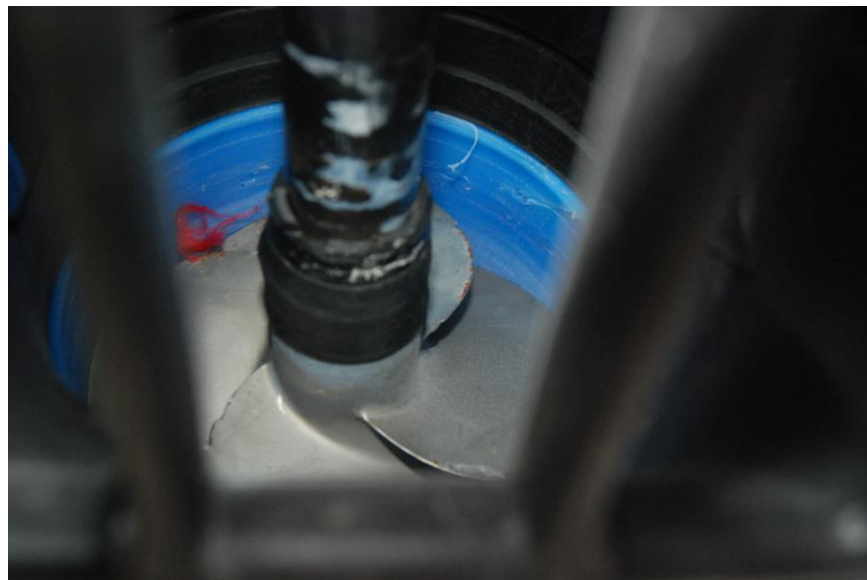
Inspection of the vessel showed debris in the impeller.
