# ATA Associates, Inc.

Re: 2014 Sea Doo GTX 155S

## SUMMARY INSPECTION REPORT

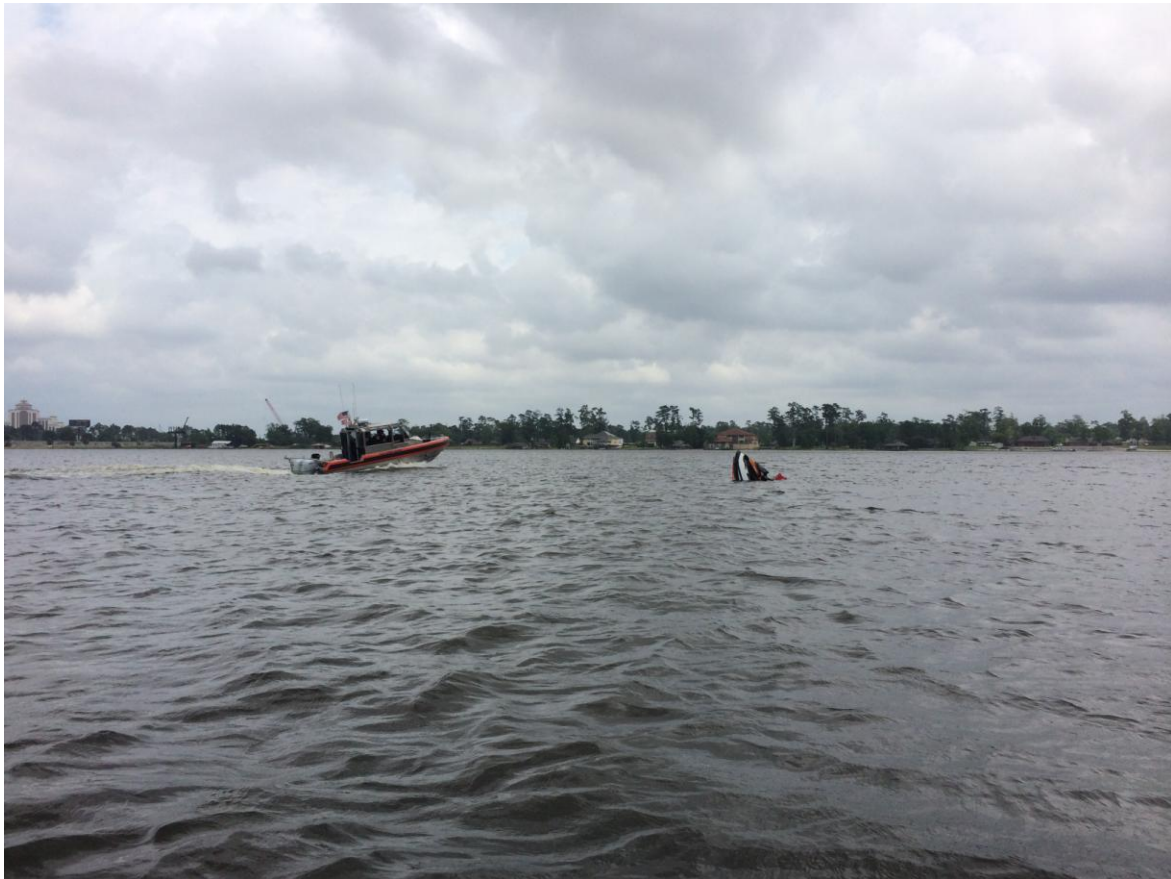
ATA Associates, Inc. was called about failure and eventual partial sinking of a 2014 Sea Doo GTX 155S personal water craft. Information from the owner, Mr. Robert Belt, indicates that the vessel, on its maiden voyage, ingested a foreign object into the impeller. Shortly thereafter, a plastic exhaust component called a resonator melted and allowed water to fill the hull of the vessel. The vessel quickly sank and was permanently damaged.
